# THE EFFECTS OF STEPPED-UP MEASURES FOR SLOWING DOWN THE SPEED IN THE ETC LANE

**Akira MITSUISHI , Hiroshi OGAWA, Masatoshi YOKOTA**

*East Nippon Expressway Company Limited*

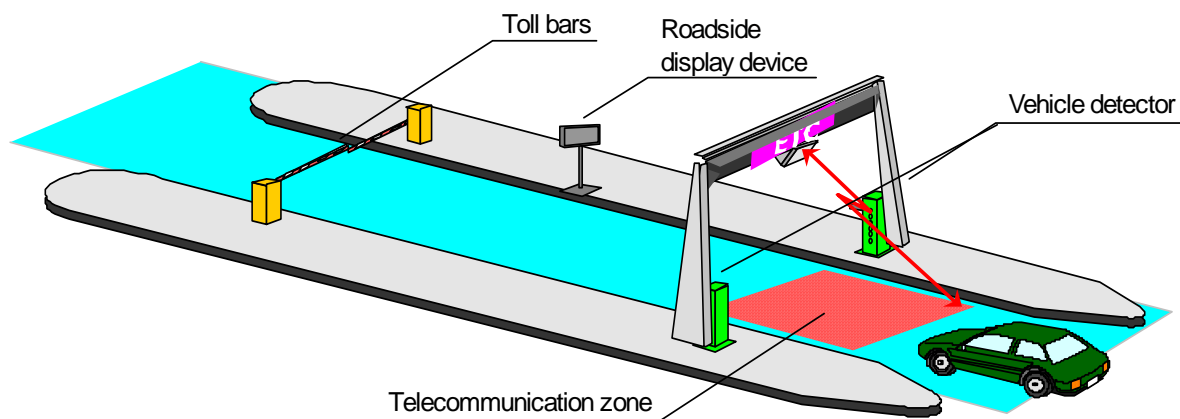
Figure 1. Overview of ETC lane

When a vehicle passes through the vehicle detector (see Figure. 1), a signal that activates the toll bars is generated. In the conventional system, there was little time lag between the detection by the detector and generation of the toll bar activation signal. According to the stepped-up measures, by changing the timing at which

The vehicle detector (Fig. 1) located most upstream of the ETC lane was used as a trigger to activate the LED display device, as in the stepped-up measures for slowing down the speed. Therefore, since the distance between the vehicle detector and the LED display device was not sufficiently long (merely more than 10 metres), multi-step change of information displayed on the LED display device was made within a short time.

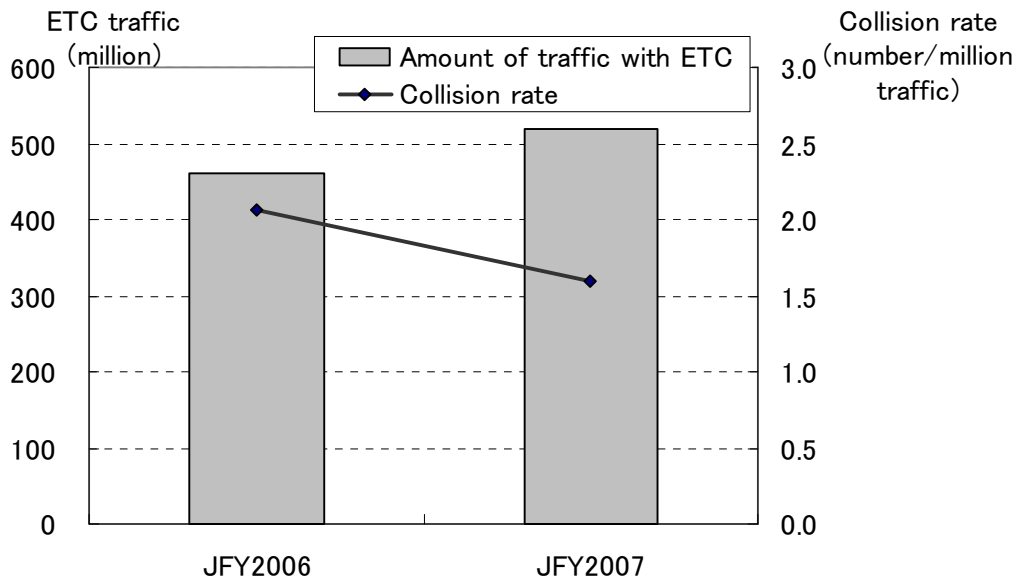
Figure 4. Collision accidents in the ETC lane  
(According to NEXCO East)

In the NEXCO East area, no fatal accidents have so far occurred in the ETC lanes. However, there seems to be no end to accidents that involve collision with toll bars or stopped traffic.

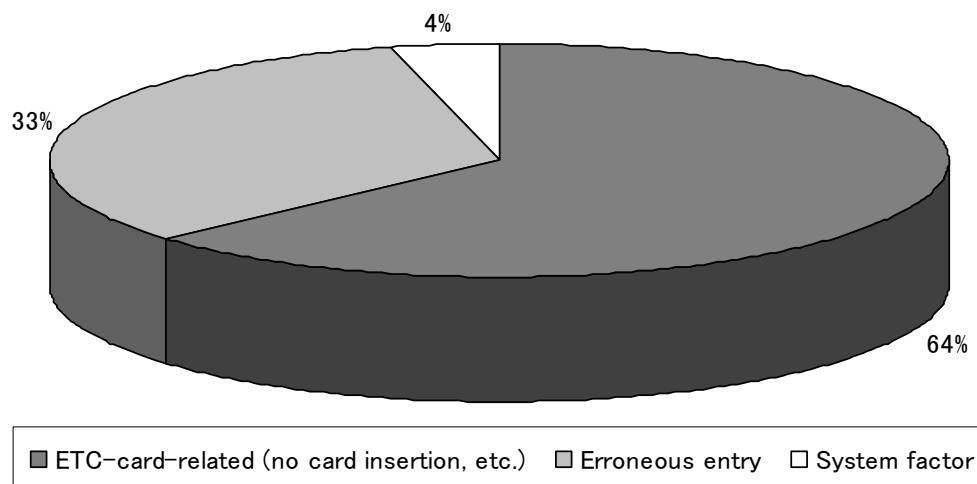
Figure 5. Causes of ETC system stop  
(According to NEXCO East in JFY2007)

In 2008, the ETC system stopped and the toll bars did not open for one out of approximately every 580 vehicles. Investigation of the causes showed that over 60% of the accidents resulted from ETC-card-related problems (no insertion of the card, improper card insertion, expired card, and the like) and over 30% resulted from vehicles without an ETC device entering into the ETC lane by mistake.

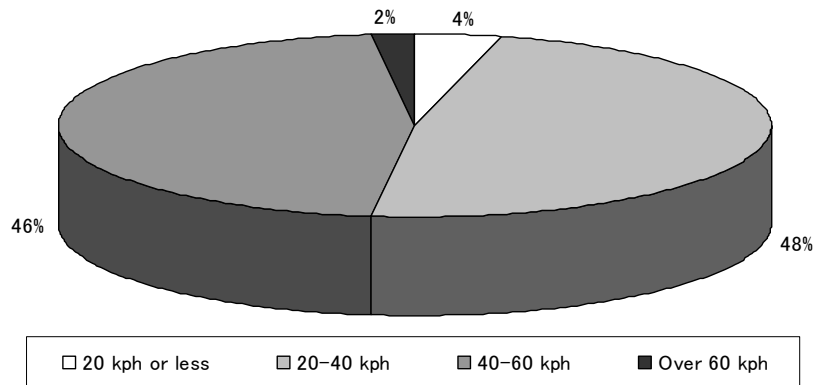
Figure 6. Speed distribution in the ETC lane when collision accident occurred (According to NEXCO East in JFY2007)

Investigation of the collision accidents in the ETC lane revealed that over 90% of the drivers entered the ETC lane at a speed of over 20 kilometres per hour. Thus, it is assumable that the speed makes it difficult for the drivers to stop safely.

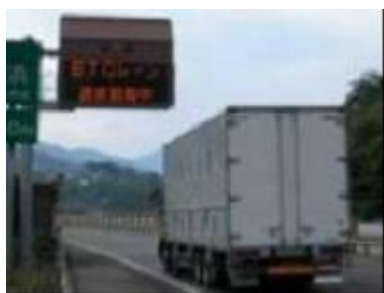
Photo 1. Information on variable message sign

In order to lower the speed of vehicles passing through the ETC lane and reduce trouble such as collision with the toll bars through the implementation of the measures, it is necessary that customers such as drivers fully understand the details and the purpose of the measures. Therefore, PR activities were carried out. The locations where the PR activities should be conducted were discussed to include various locations before driving, on the expressway, and immediately before the ETC lane. For drivers before driving, the information was aired on the radio commercial. For drivers on the expressway, the posters were put up and leaflets were distributed in rest areas, and the information was provided on variable message signs and through the expressway radio. Sign boards and LED display devices were installed, and security officers alerted drivers immediately before the ETC lane (LED display devices were installed only for the first 2 to 3 months at trial sites where the amount of traffic was relatively

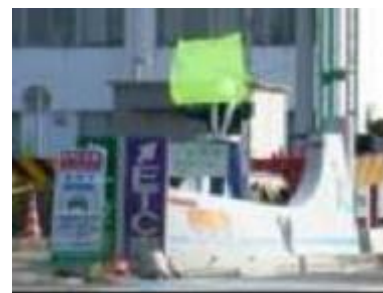
Photo 3. Security staff alerting drivers

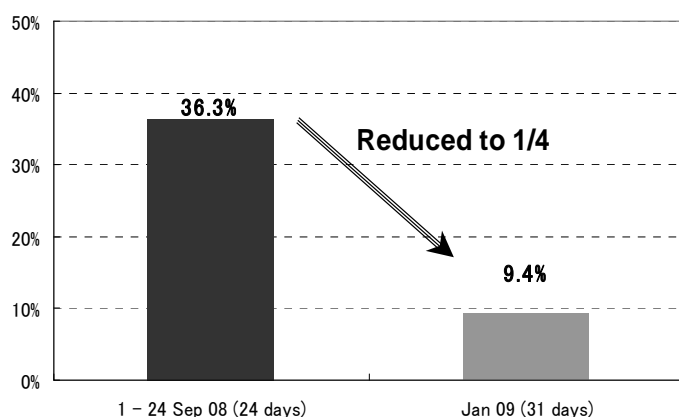
Figure 8. Transition of the share of vehicles number at 40 kph or higher at Niigata West entrance toll gate

At the Hokuriku Expressway Niigata West toll gate, which is in accord with the mainline toll gate in terms of type and traffic, the trial started in 25 September 2008. It was found that the share of vehicles number passing at a relatively high speed of 40 kilometres per hour or higher has been reduced to 1/4, and the rate of number of vehicles colliding with the toll bars has been reduced to 1/2 or less. In addition, four months after the initiation of the trial, the measures have still been effective. It is thought that these successes are the result of the sufficient promotion of the measures and drivers' good understanding of the purpose of the measures. Moreover, there have been no accidents or complaints reported.

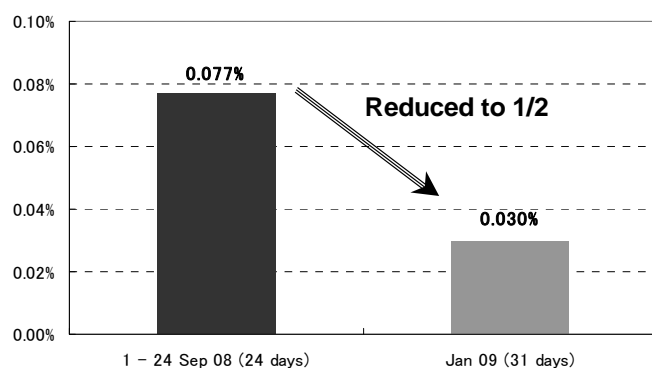
Figure 10. Transition of the rate of number of vehicles colliding to the toll bars at Niigata West entrance toll gate

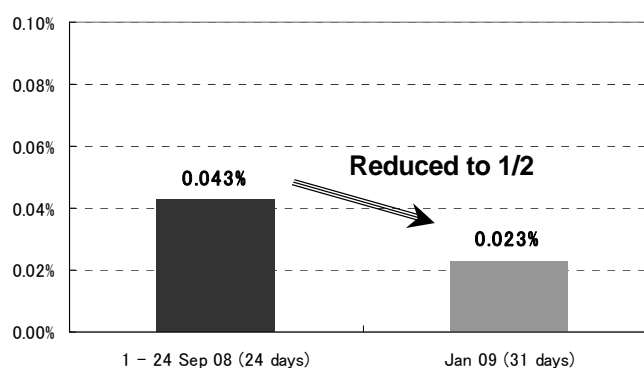
Figure 11. Transition of the rate of number of vehicles colliding to the toll bars at Niigata West exit toll gate

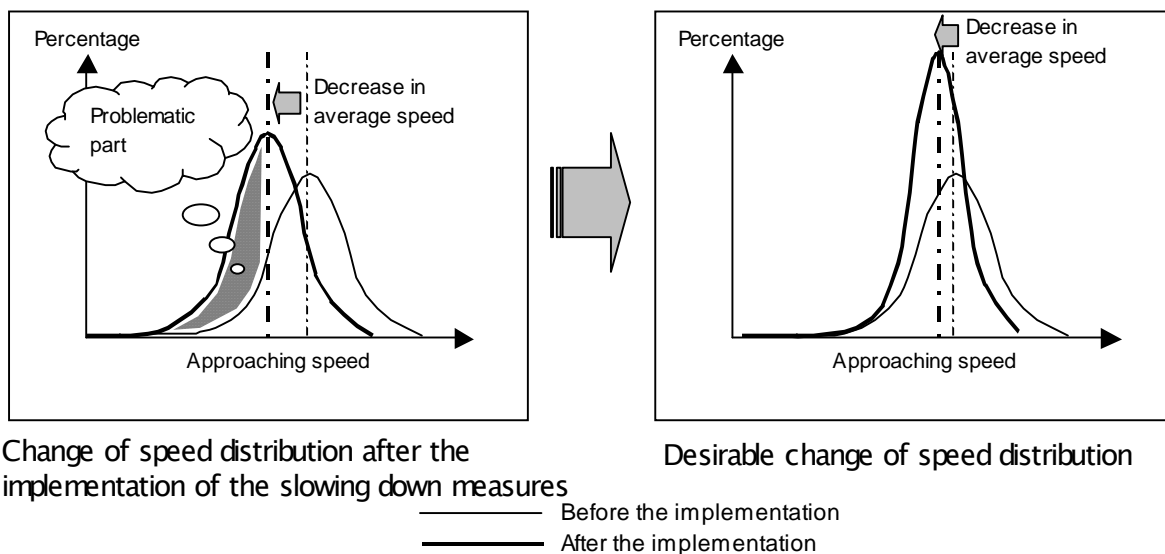
Figure 12. Change of speed distribution

The data from the trial previously conducted by NEXCO Central showed that the measures caused the overall speed distribution in the ETC lane to shift to a lower speed range. Namely, it was found that not only drivers who normally passed at a relatively high speed, but also drivers who normally passed at a relatively low speed are passing at an even lower speed than before. For this reason, the following issues are assumed.

(2) In order to achieve a smooth flow of traffic, the speed distribution needs be as small as possible. According to the trial results by NEXCO Central, there is a possibility that the measures widened the speed distribution.

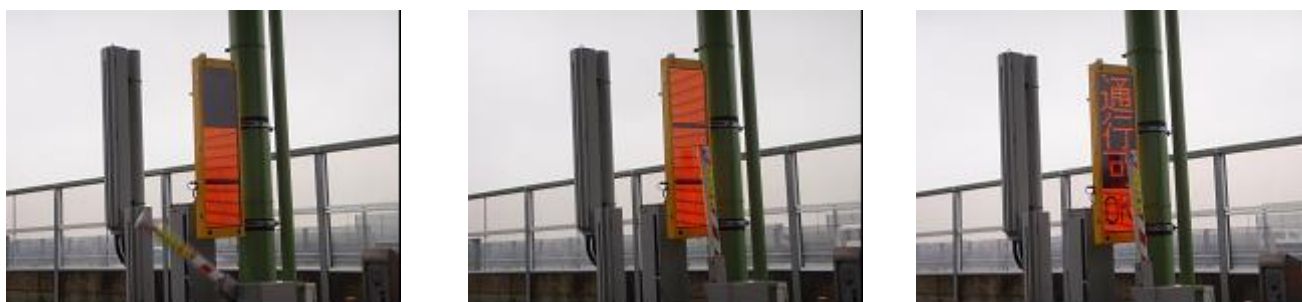
Photo 4. Installation of LED display device

In view of the existing equipment and the like, a general-purpose LED display device was installed near the toll bars. The timing at which the toll bars opened was displayed by providing information in a countdown manner.

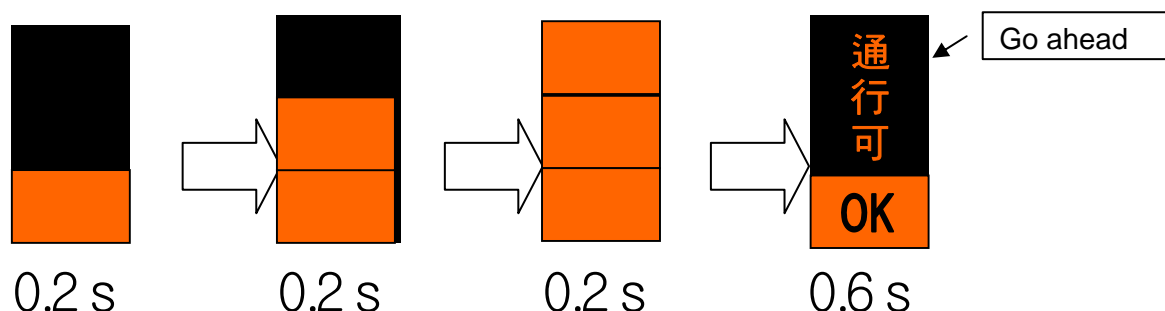
Figure 13. Information displayed and switching time of LED display device ("s" for second)

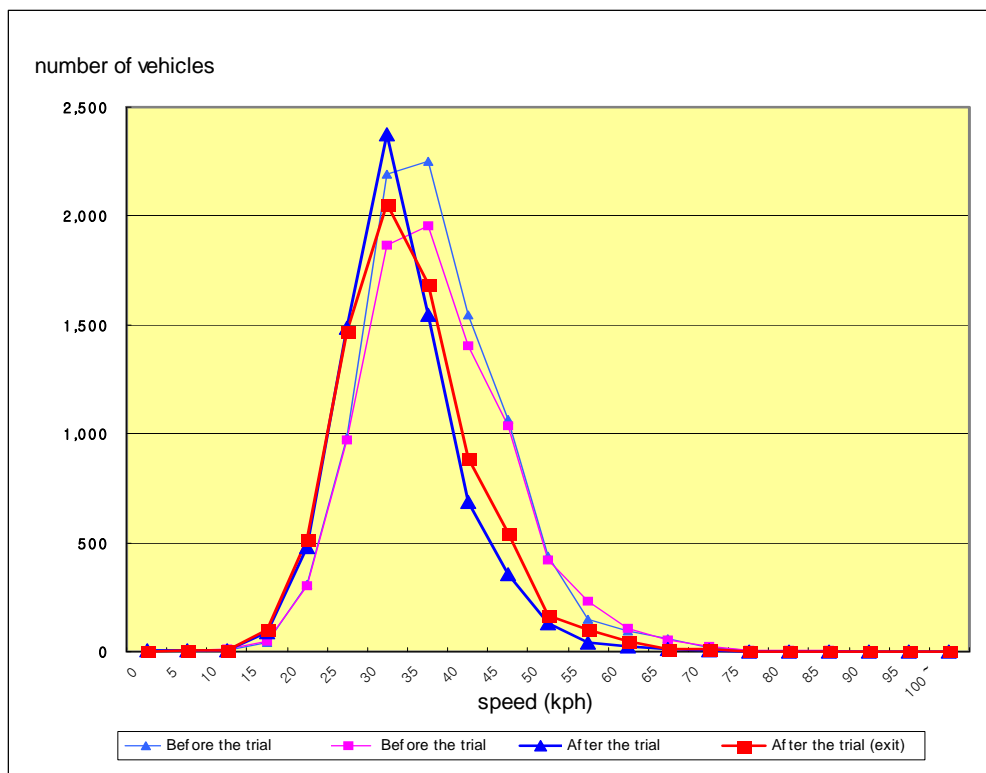
Figure 14. Speed distribution in the ETC lane at Niigata West toll gate (before and after the implementation of the trial for slowing down the speed)

The distribution of approaching speed into the ETC lane shows no significant differences between the exit at which the trial for slowing down the speed was implemented and the entrance at which the trial was not implemented. However, since a decrease in the high speed range was seen at the exit, it can be assumed that the result is attributable to the effects of the display of the timing at which the toll bars open.
